Bone block, implant, split-thickness flap, reconstruction and restoration

Restoring a single-tooth space

Dr Hermann Derks and Wilfried Lesaar, Emmerich/Germany

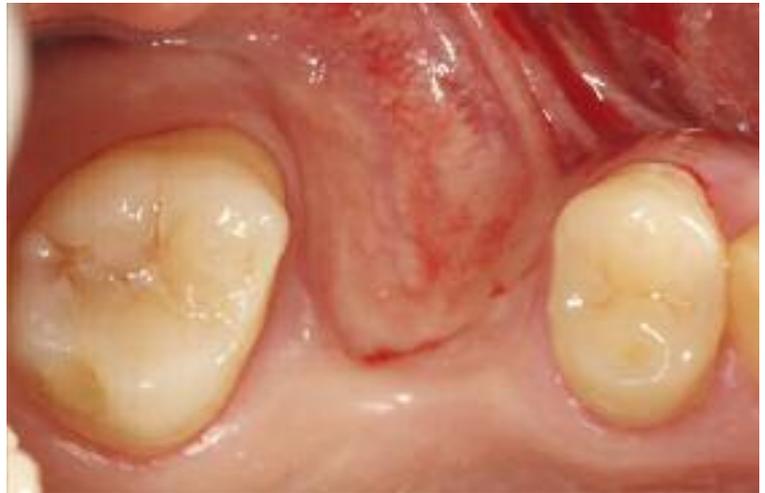
Fig. 1 Clinical baseline situation. A buccal advancement flap according to Rehrmann had been created several years previously.

A 29-year-old male patient was referred to our office for restoration of the missing tooth 16. The patient's medical and dental history was normal. The third molars were absent; several teeth have been restored with adequate fillings. The occlusion was stable and normal. The periodontal tissues were free of inflammation. Tooth 16 had been extracted several years previously. A perforation of the maxillary sinus had been closed with a buccal advancement flap according to *Rehrmann*. Because the oral mucosa had been extensively mobilized at the time, the alveolar ridge at the site was covered with mobile mucosa, reaching all the way to the palatal side at the time of the baseline examination (Fig. 1). A vertical and horizontal (mesial) osseous defect was diagnosed radiologically (Fig. 2).

The baseline photograph shows the mobile mucosa covering the entire erstwhile extraction socket (see Fig. 1). The importance of the presence of keratinized mucosa at the implant neck has not been described conclusively in the literature. So far there have been no scientific data suggesting reduced success or survival rates for implants placed in mobile mucosa. However, clinical practice has demonstrated the advantages of keratinized mucosa, not least with regard of oral hygiene. It is therefore hardly surprising that the presence of mobile mucosa has been described as a risk factor in mucositis [8], although not in peri-implantitis [8,9]. In the case presented here, creation of a split flap produced a 2 to 3 mm wide zone of keratinized mucosa. ■

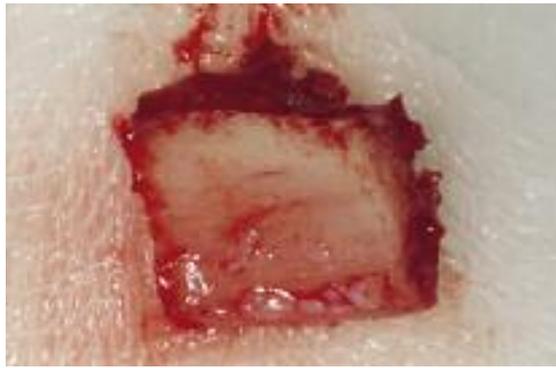
Fig. 3 A bone block was piezosurgically harvested at site 48.

A bone block was harvested piezosurgically at site 48 (Fig. 3) after an extensive flap had been prepared at site 16 to accommodate this bone block. When the bone was exposed at the implant site, the pre-existing perforation of the maxillary sinus turned out to be covered with soft tissue only. To maximize the contact area with the bone at the augmentation site, the bone block was prepared appropriately. The graft was

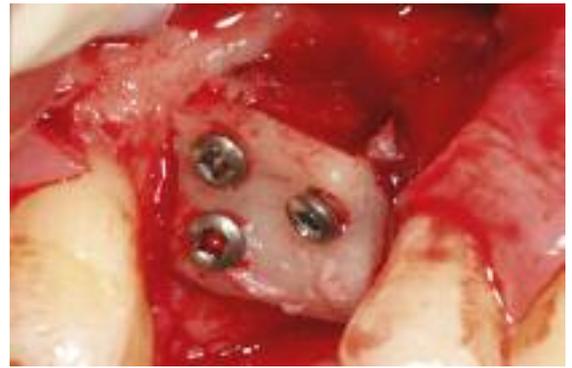
Fig. 4 The bone graft was secured in place with three screws.

secured with three screws (OsteoMed) (Figs. 4 and 5). A membrane (BioGide) was buccally anchored using two bone pins (Friatec). The remaining undercut were filled with a bone substitute (BioOss) (Fig. 6). The membrane foil was secured palatally with a 6-o Gore-Tex suture (Fig. 7), whereupon the mucosal flap was mobilized so the graft could be covered without tension and sealed to prevent saliva from entering (Fig. 8).

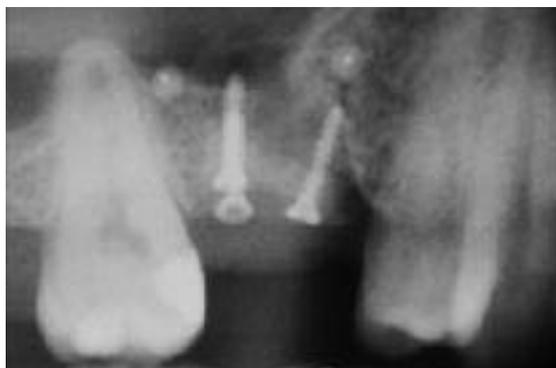
Fig. 5 Control radiograph following the fixation.

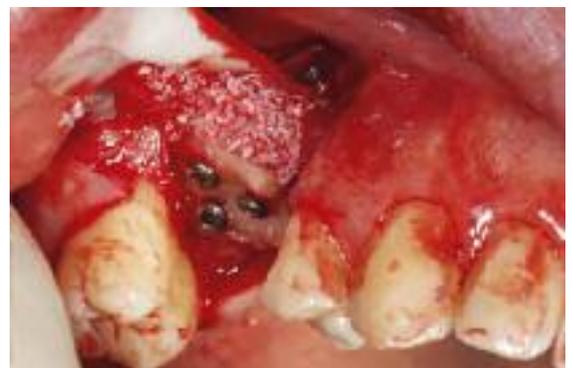
Fig. 6 A small pin and bone substitute were used to stabilize the membrane.

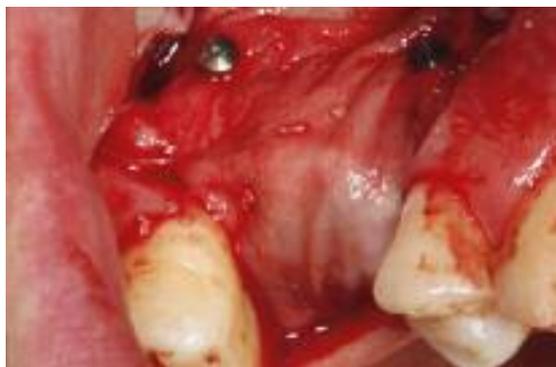
Fig. 7 The graft completely covered the site and was secured by a palatal suture.

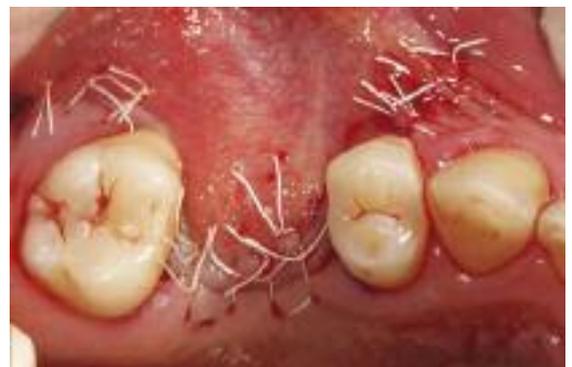
Fig. 8 The suture was free of tension and impervious to saliva.

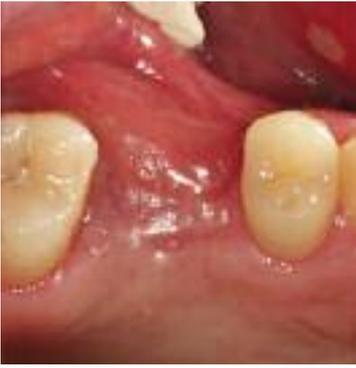
Fig. 9 The alveolar ridge prior to reentry.

The first healing phase was uneventful (Fig. 9). The screws that held the graft in place were removed (Fig. 10), and the patient was ready for implant insertion (SIC) (Figs. 11 and 12). To improve the soft-tissue situation, a split flap was used (Figs. 13 and 14). The objectives were to cover the implant completely (Fig. 15) and to harvest keratinized mucosa on the buccal aspect of the future crown (Fig. 16). Figure 17 illustrates the situation two weeks after the surgical intervention.

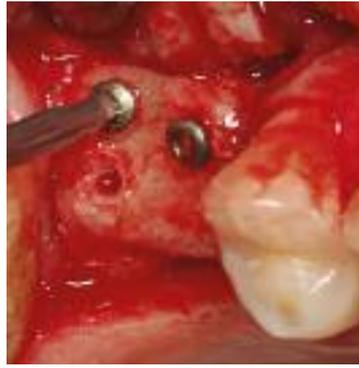
Fig. 10 The screws were removed and ...

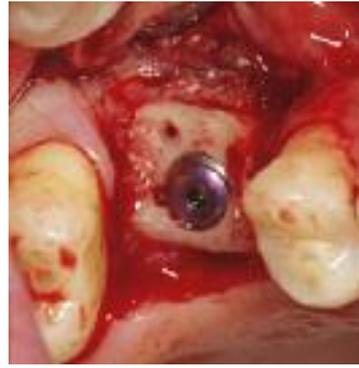
Fig. 11 ... an implant was inserted.

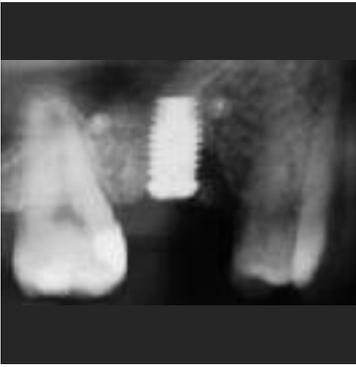
Fig. 12 Control radiograph following the implantation.

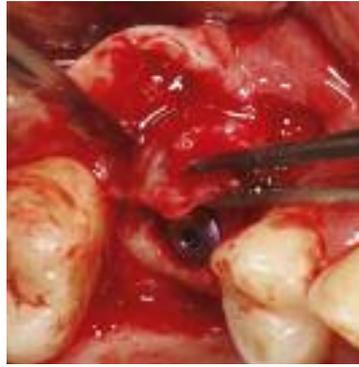
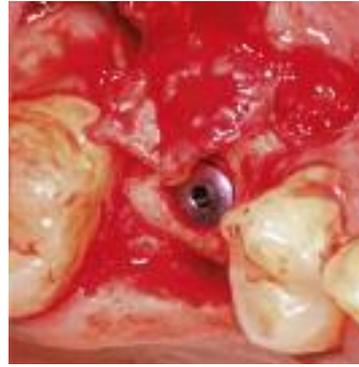
Figs. 13 and 14 Creation of a split-thickness flap.

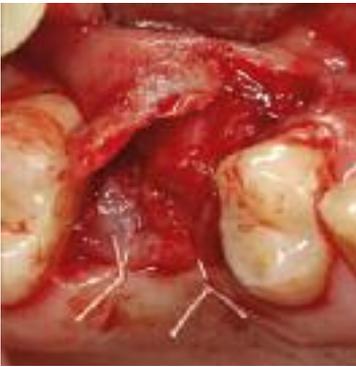
Fig. 15 The sutured internal flap ...

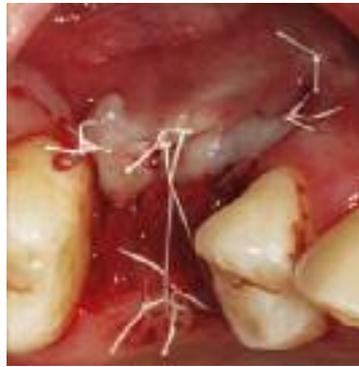
Fig. 16 ... and the relocated external flap.

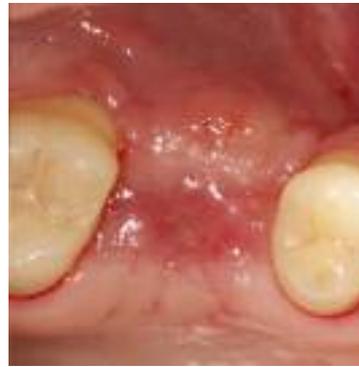
Fig. 17 Two weeks after the procedure.

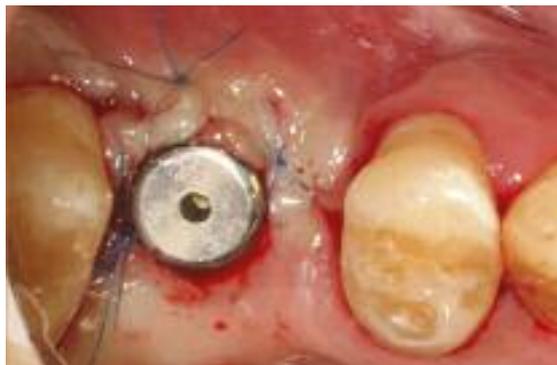
Figs. 18 and 19 Connection of the healing abutment and subsequent control radiograph.

A healing abutment could be connected three months later (Figs. 18 and 19). Figure 20 shows the position of the healing abutment after six weeks in situ. At the same appointment, an open-tray impression was taken for the definitive crown. The crown was fabricated conventionally (Figs. 21 to 23) and cemented with Harvard cement at delivery (Figs. 24 and 25).

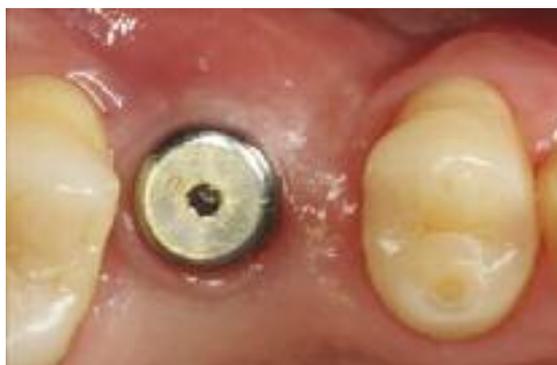
Fig. 20 The healing abutment after three months.

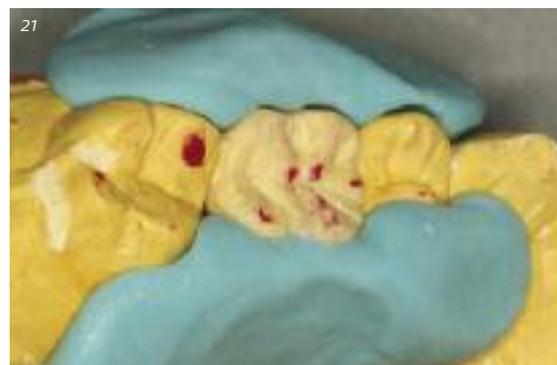
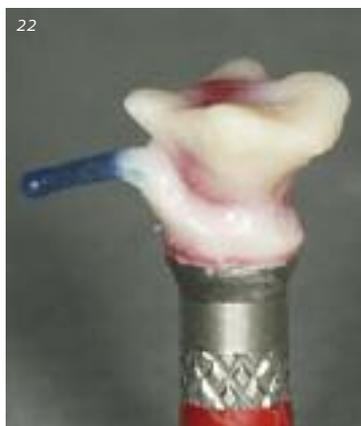
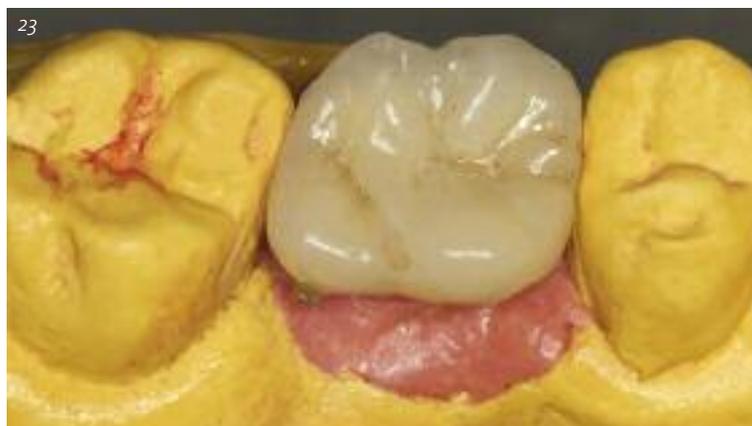
Figs. 21 to 23 The crown was fabricated using conventional methods.

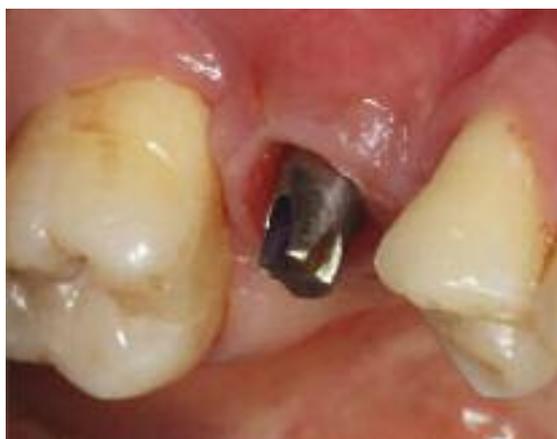
Fig. 24 The definitive abutment was connected prior to the delivery of the crown.

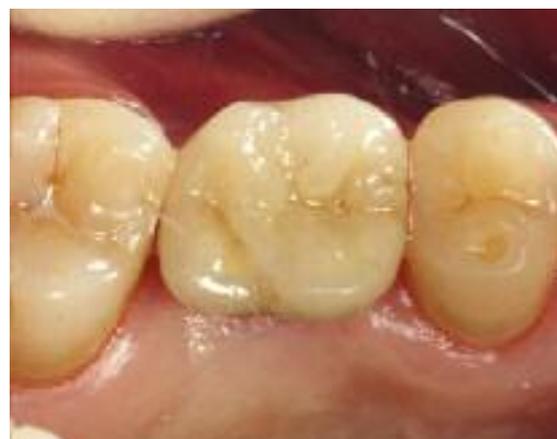
Fig. 25 The cemented crown on the implant at site 16.

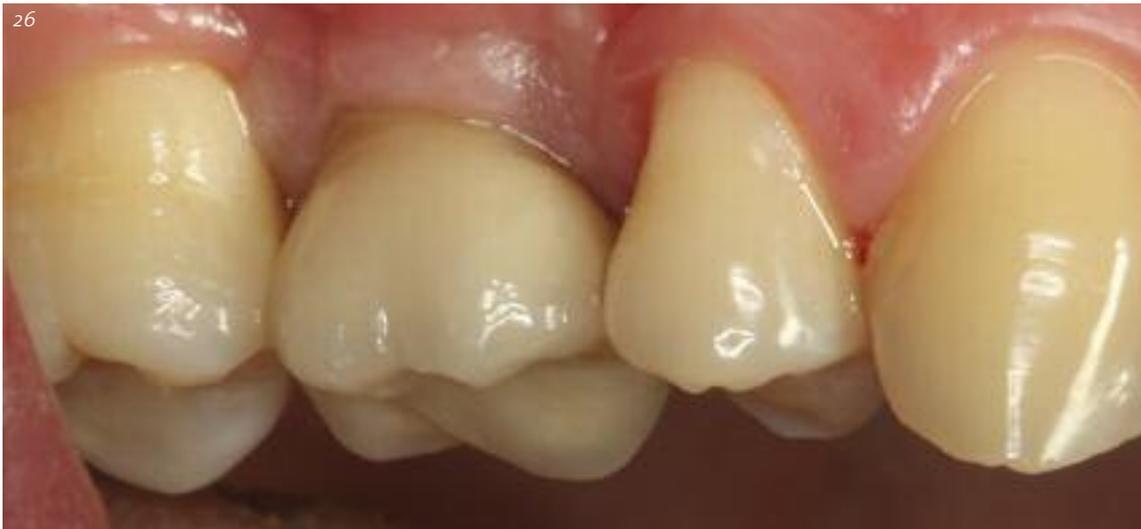
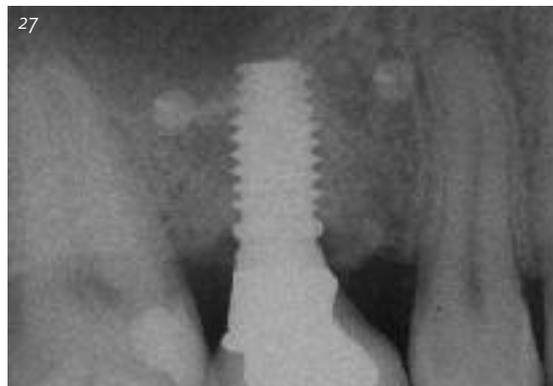
*Figs. 26 and 27
At two years
postoperatively,
the situation was
stable.*

At two years postoperatively, the situation was stable. By agreement with the patient, the bone pins were left in place (Figs. 26 and 27).
